After a winter restoration, the famed Hornbeam Ellipse is almost back

By **Adrian Higgins**

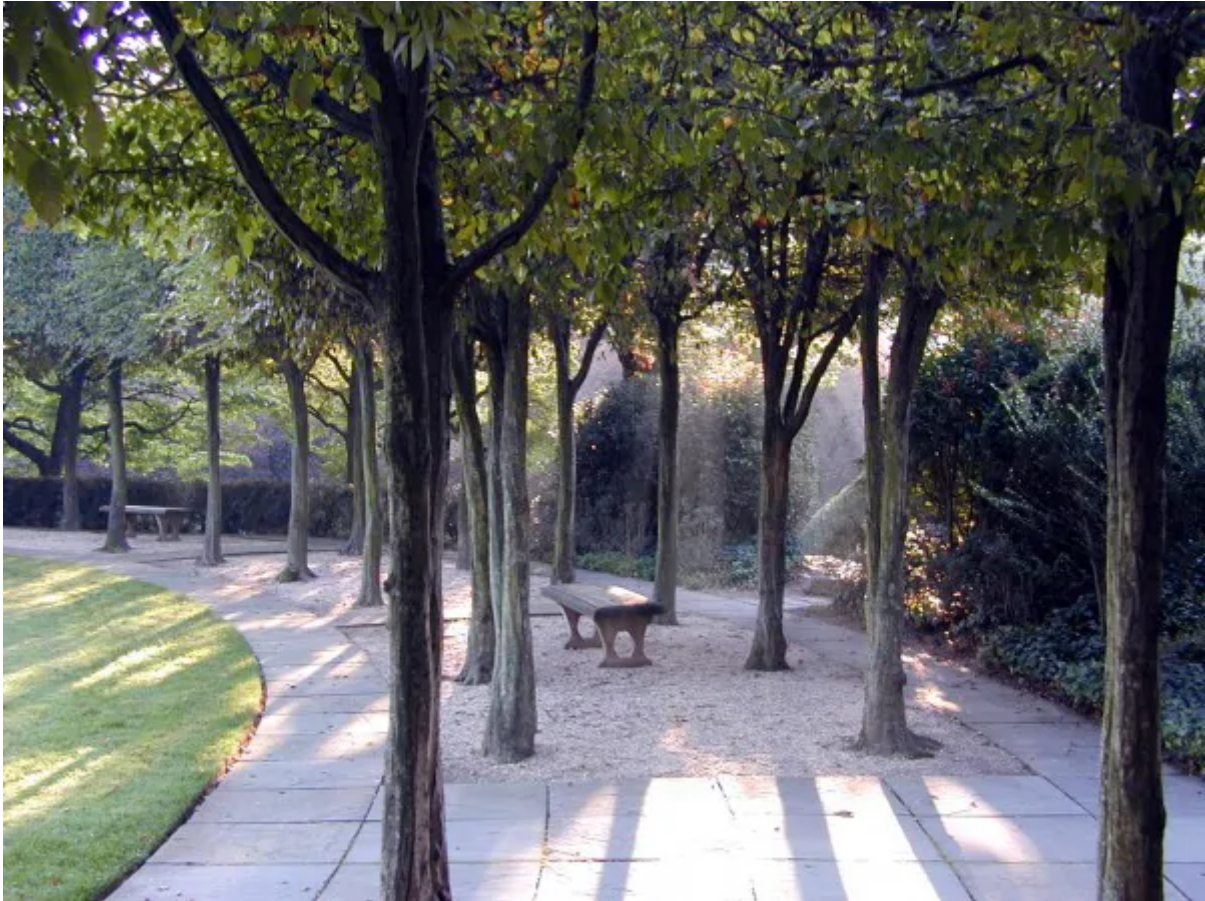
The Hornbeam Ellipse at Dumbarton Oaks has been in steady decline for years. It is now the subject of a major renovation. (Dumbarton Oaks/Dumbarton Oaks)

Keen-eyed visitors over the years will have noticed that while the hedge has remained fairly intact, the trees have been ailing. “There should be 76 trees,” said Jonathan Kavalier, director of gardens and grounds. “We were down to 41.” The trees that remained had lost vigor and required just one clipping a year (in early July), instead of the earlier two annual trims.

What happened to the old trees? They were getting on a bit, and the constant clipping added its own stresses, but the principal concern was with the soil, which had grown dense and lifeless. This may be due to the way each of the planted panels — there are 13 of them between radial paths — were dressed in a gravel. This invited people to walk on them, which added to the soil compaction.

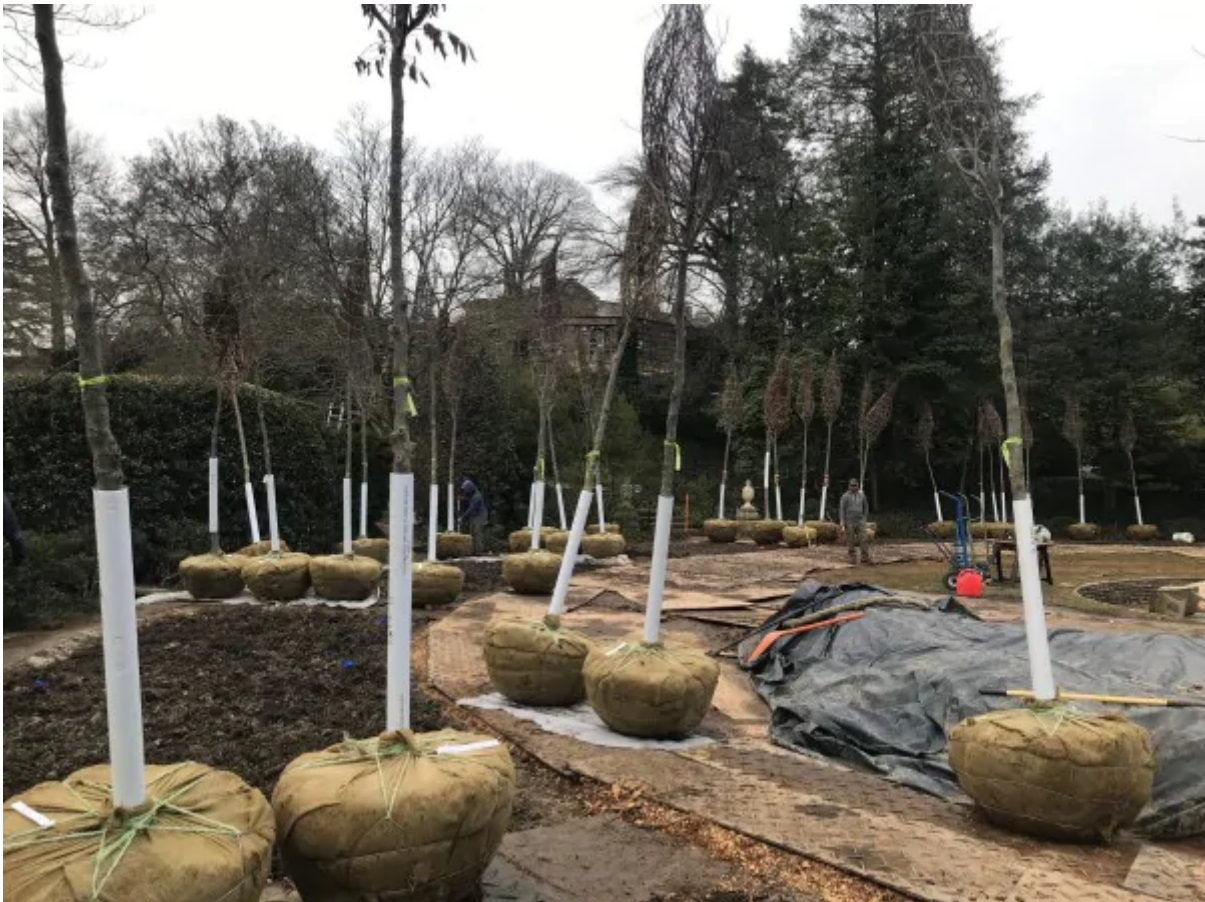
By early April, gardeners will install 76 new trees after two months of wholesale soil replacement. (Luis Marmol/Luis Marmol/Dumbarton Oaks)

Kavalier convinced his bosses that the scope of the renovation should increase significantly with the wholesale replacement of the old soil. Excavating down to three feet, gardeners removed about 350 cubic yards of old soil. They put down a 12-inch free-draining base layer. Above that the beds were backfilled with a compost-sand mixture blended with half of the original, excavated soil. The intent is to create a biosphere for soil microorganisms now known to be key to the vitality of trees. The team worked with organic soil expert Eric T. Fleisher, of [F2 Environmental Design](#), to create the soil mix.

Planting the new trees “was the easiest part of the job,” said Kavalier. “It was the soil excavation and mixing that was the tough part.” Even the tree planting had its challenges, however; the new trees had to be positioned exactly as the old ones to keep the complex geometry of the design. “We agreed that one inch would be the tolerance of deviation from the design,” he said.
